TIRE RUBBER IN HOT MIX ASPHALT PAVEMENTS

FINAL REPORT

**WISCONSIN FEDERAL EXPERIMENTAL PROJECT # WI 89-04
and
WISDOT RESEARCH STUDY # 93-01a**

FINAL REPORT # WI-06-02

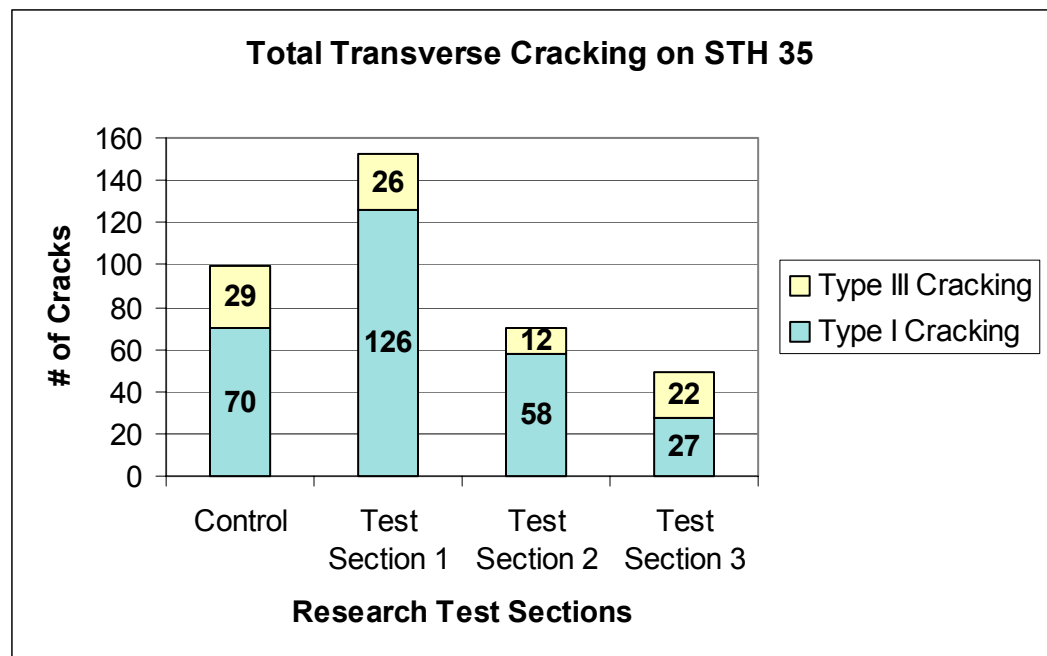
Figure 3.

Overall, Test Section 1 (virgin HMA surface course and recycled CRM RAP lower course) had the highest number of transverse cracks, 17 percent of which were banded. Although Test Section 3 (recycled CRM RAP surface course and virgin HMA lower course) had the least amount of transverse cracks, it had the highest percentage of Type III banded transverse cracks, at 45 percent (see Figure 3 below).

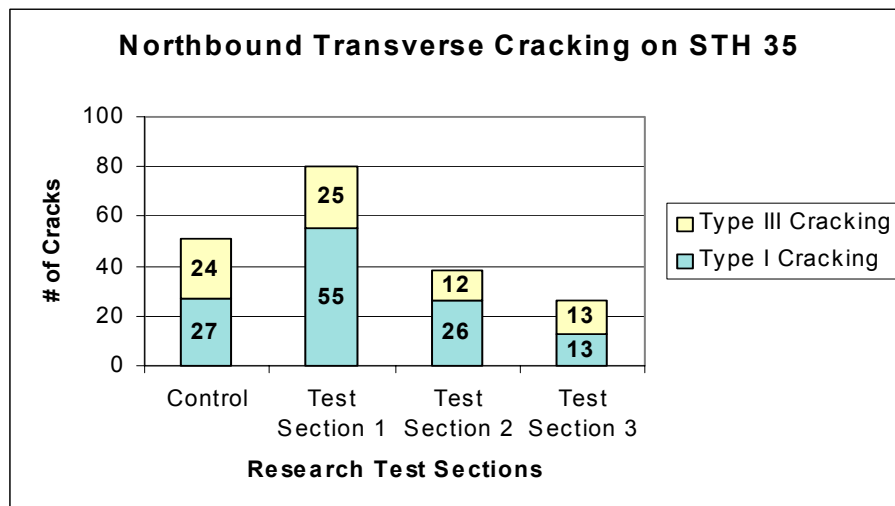
Figure 4.

As previously mentioned, the southbound lane generally performed better than the northbound lane throughout the length of the test and control sections, with primarily Type I, and far less Type III, transverse cracking (see Figures 4 & 5, below). In fact, Test Section 2 didn't have any Type III transverse cracks, and Test Section 1 only had one, in the southbound lane.

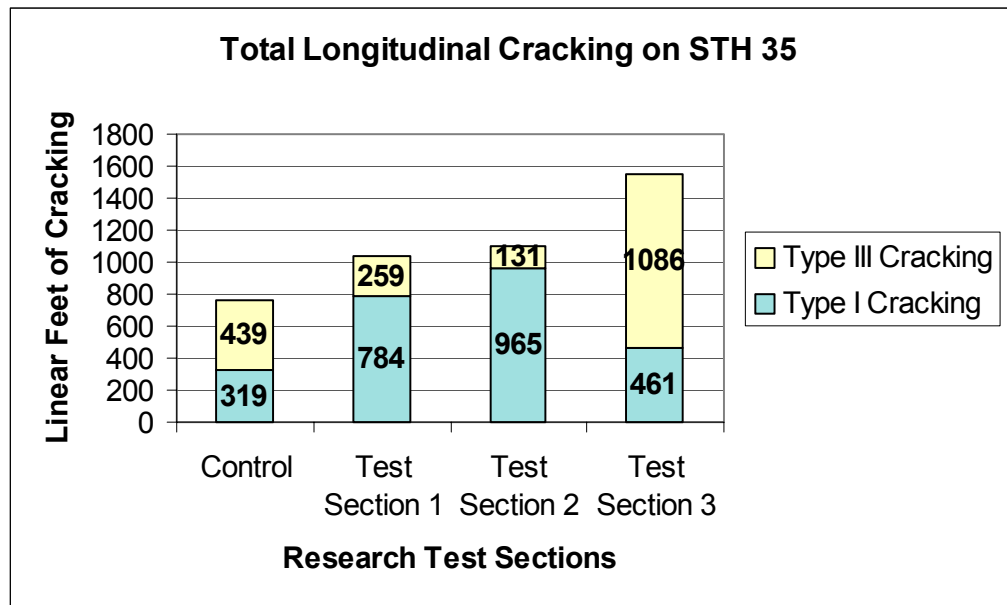
Figure 6.

The total linear footage of longitudinal cracking was measured in the northbound and southbound lanes of a 500-foot monitoring segment within each test section (see Figures 6-8). Figure 6 shows that the Control Section (virgin HMA surface and lower course) had the least amount of longitudinal cracking while Test Section 3 (recycled CRM RAP surface course and virgin HMA lower course) had the highest amount. Test Sections 1 & 2 (virgin HMA surface course and recycled CRM RAP lower course; and, recycled CRM RAP surface and lower course, respectively) had the least amount of Type III banded longitudinal cracking, particularly in the southbound lane (see Figures 7 & 8, page 33). Although the values are accurate for the 500-foot monitoring segments, they may not be truly representative of the longitudinal cracking present in the entire 2600-foot sections, as there were performance discrepancies within the test sections.
